NASA CONTRACTOR REPORT 159057

MODIFIED CARBON FIBERS TO
IMPROVE COMPOSITE PROPERTIES

R. E. SHEPLER

UNION CARBIDE CORPORATION
CARBON PRODUCTS DIVISION
PARMA TECHNICAL CENTER
PARMA, OHIO

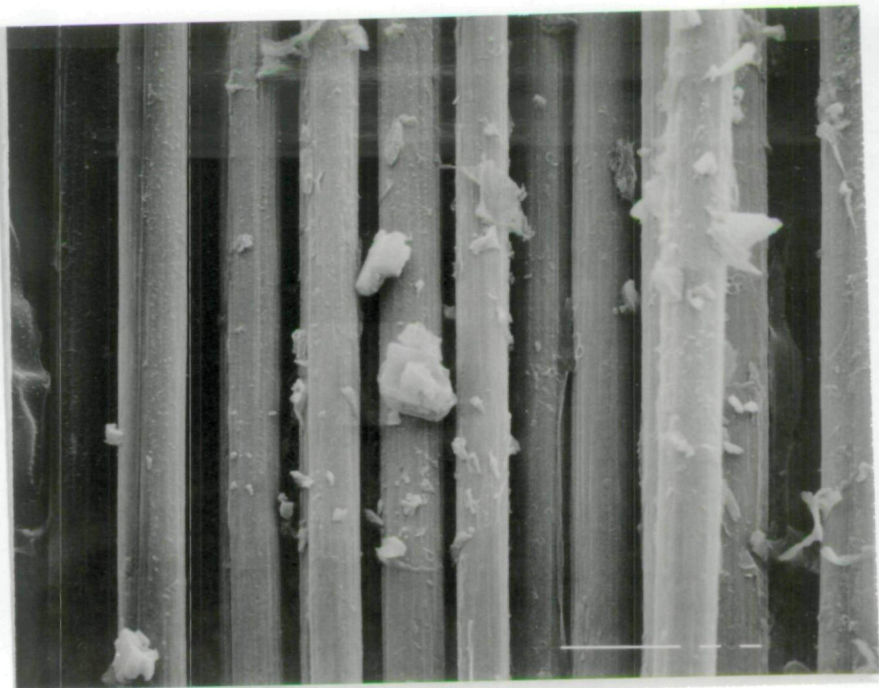
Fig. 4-19(c) SEM Micrograph from One of the
Larger Fiber Bundles After Burn Testing.
1200X

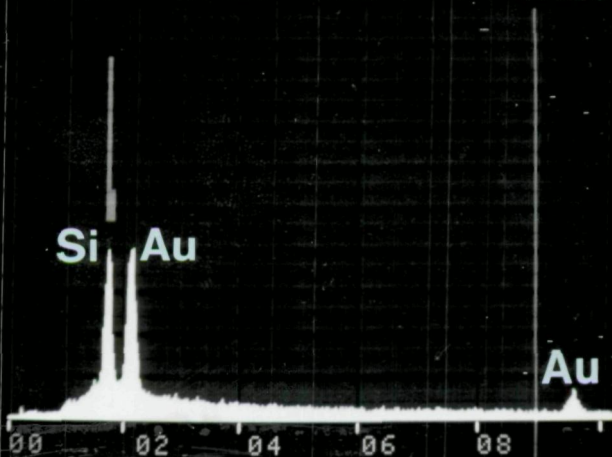
Fig. 4-19(d) Kevex Trace of
Burned Composite Showing
Gold Coating and Silicon.

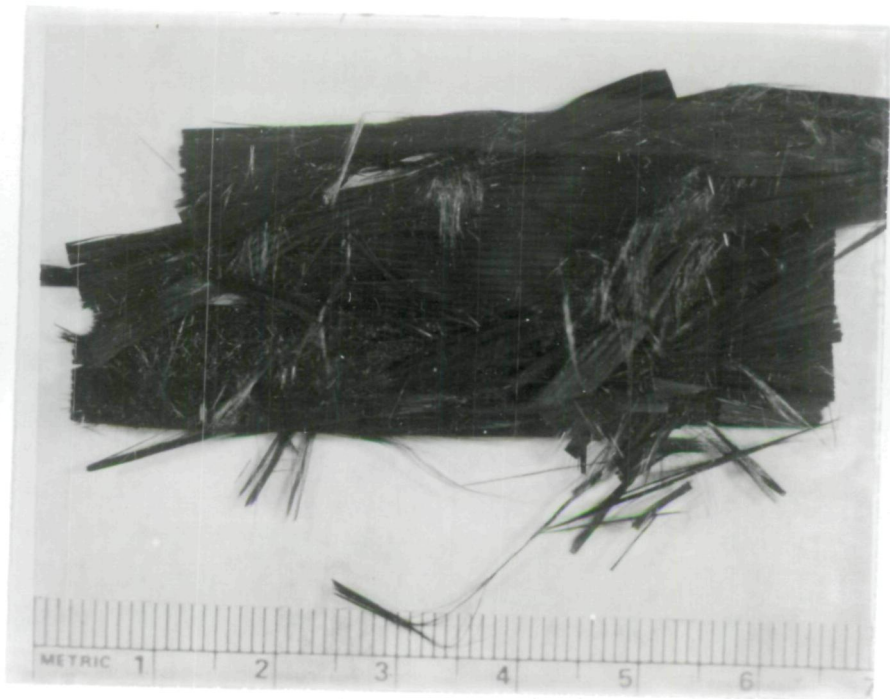
Fig. 4-20(a) Composite After 10 Minutes
Dynamic Burn Test, 850°C Max.,
1.5 x 10⁶ dyne·cm Impact Energy,
11 M/sec. Air Velocity. Approximately
50% of Fibers Burned Away. Scale is
Centimeters.

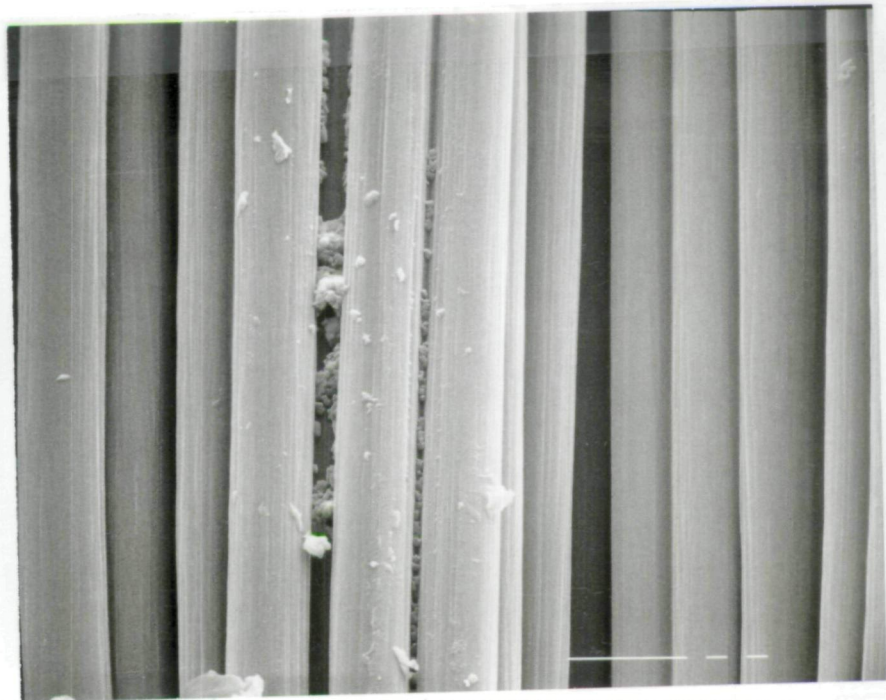
Fig. 4-20(b) SEM Micrograph from Cooler
Region of the Largest Piece
of Sample After Burn Testing.

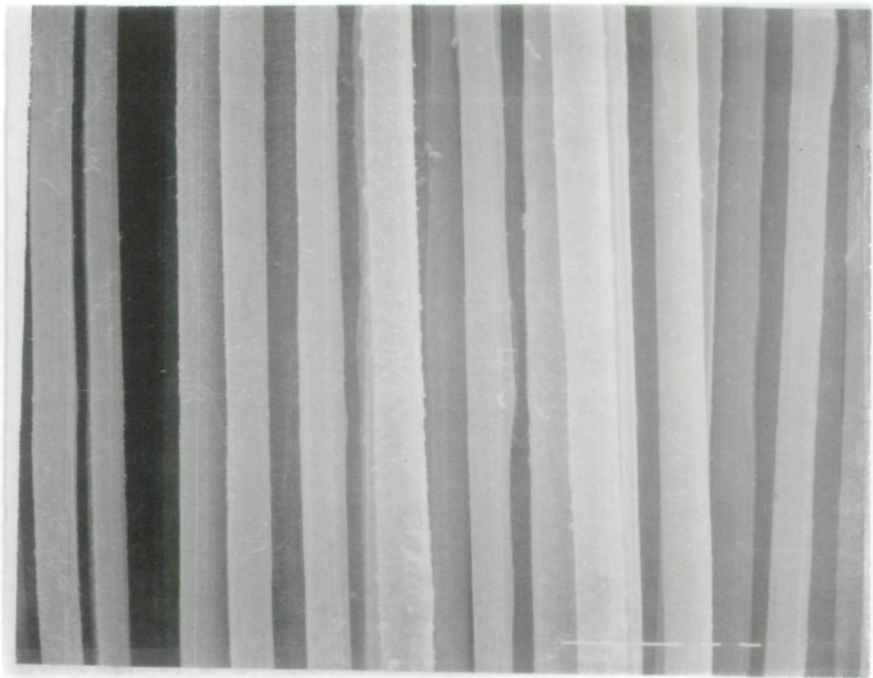
Fig. 4-20(c) SEM Micrograph from Small Fiber
Strands at Edge of Sample After
Burn Testing.

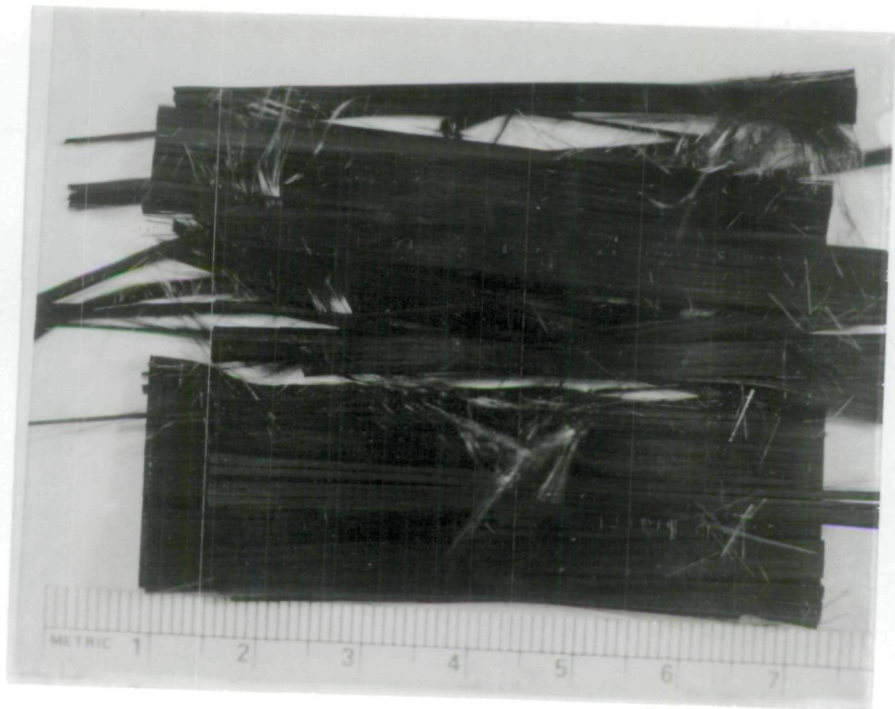
Fig. 4-21(a) Composite After 10 Minutes
Dynamic Burn Test, 850°C Max.,
1.5 x 10⁶ dyne·cm Impact Energy,
11 M/sec. Air Velocity. Scale is
Centimeters.

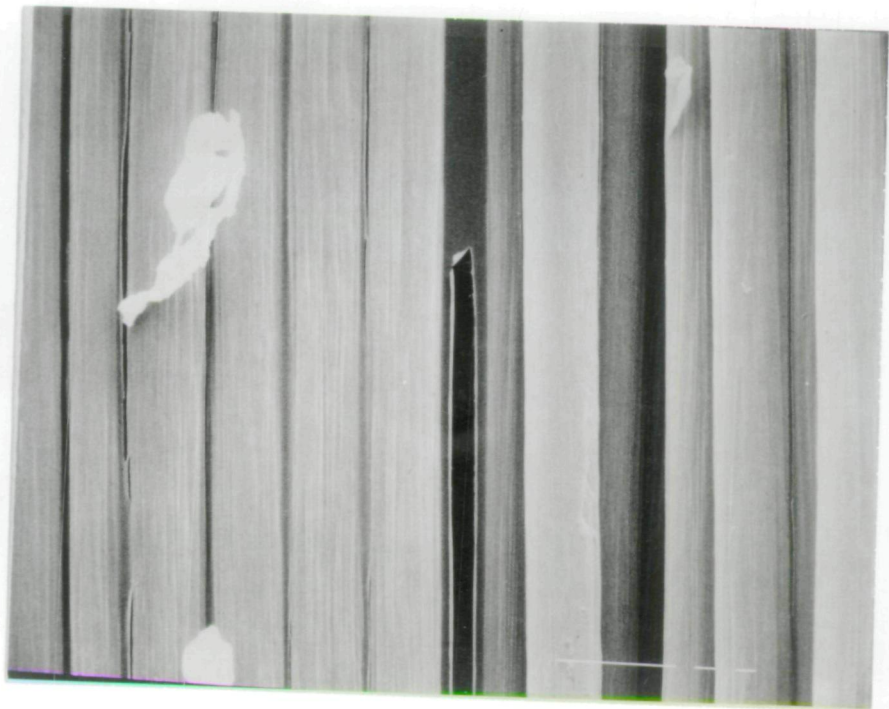
Fig. 4-21(b) SEM Micrograph from Large Piece
of Sample Remaining After Burn
Testing.

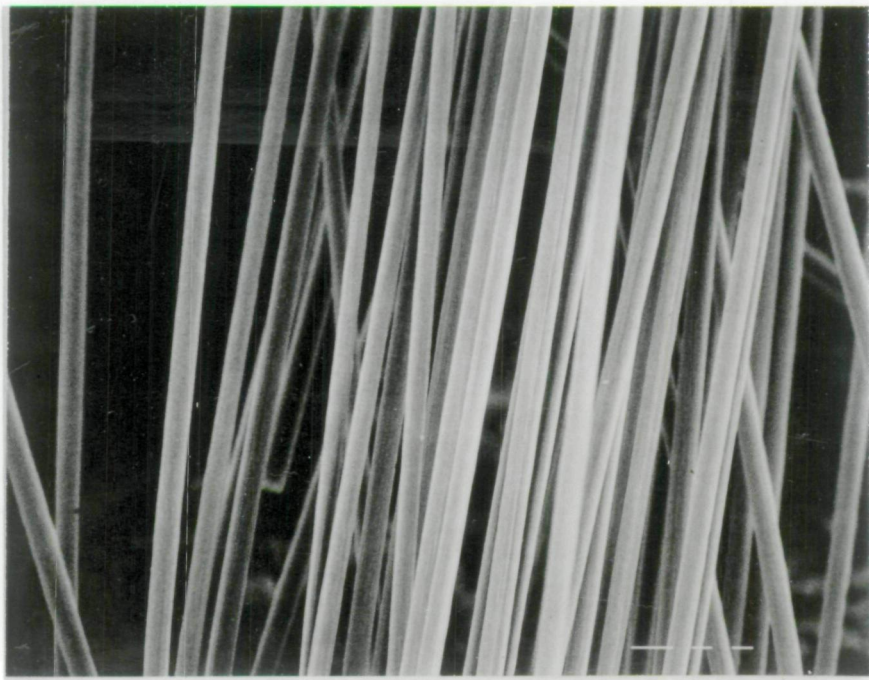
Fig. 4-21(c) SEM Micrograph from Fuzzy Edge
of a Loose Strand After Burn
Testing.

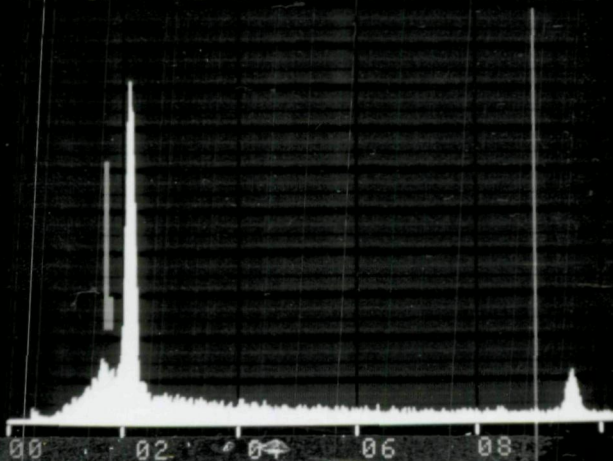
Fig. 4-21(d) Kevex Trace of Burned Composite Showing Gold Coating and Background Silicon.

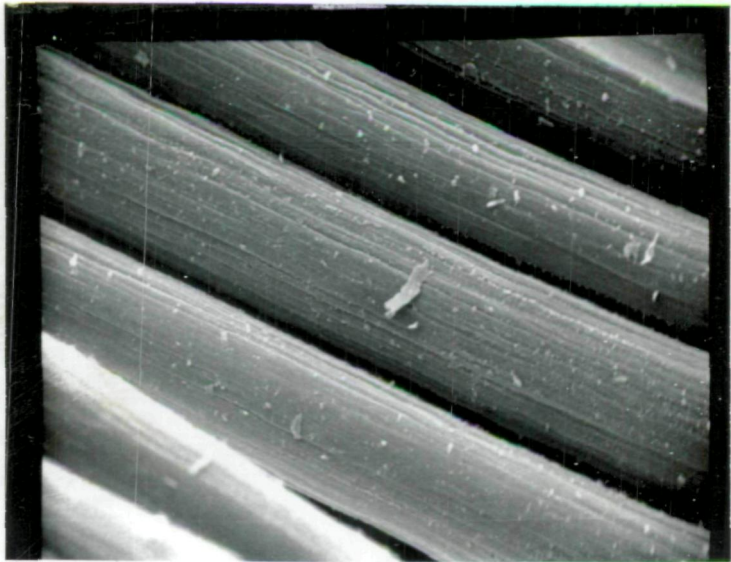
Fig. 4-23(a) Silicon Carbide Coating from
UCC L-45 Silicone Fluid.
2000X

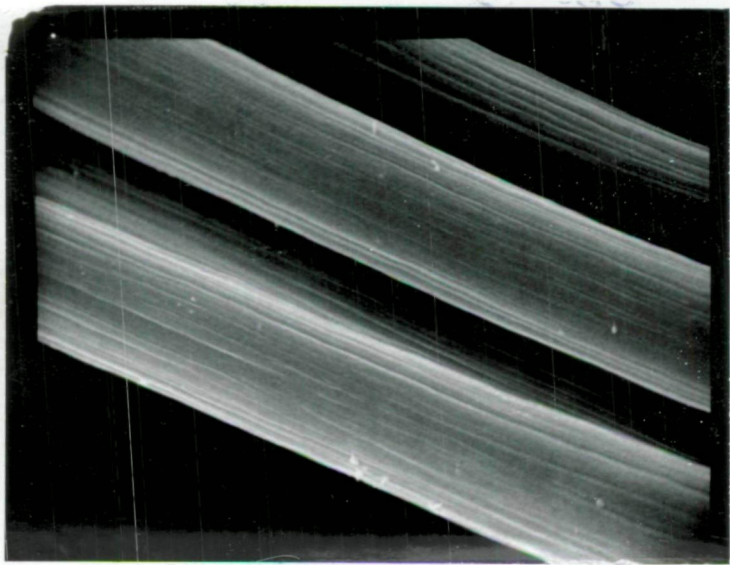
Fig. 4-23(b) Silicon Carbide Coating
from UCC L-31 Silicone Fluid.
2000X

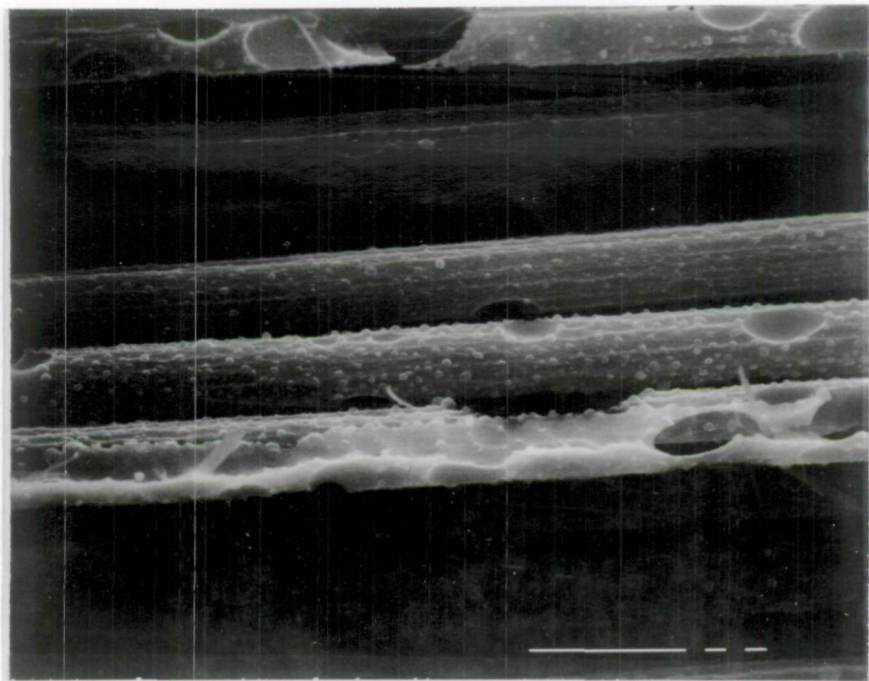
Fig. 4-24(a) Silicon Carbide Coating from
UCC L-45 Silicone Fluid.
1600X

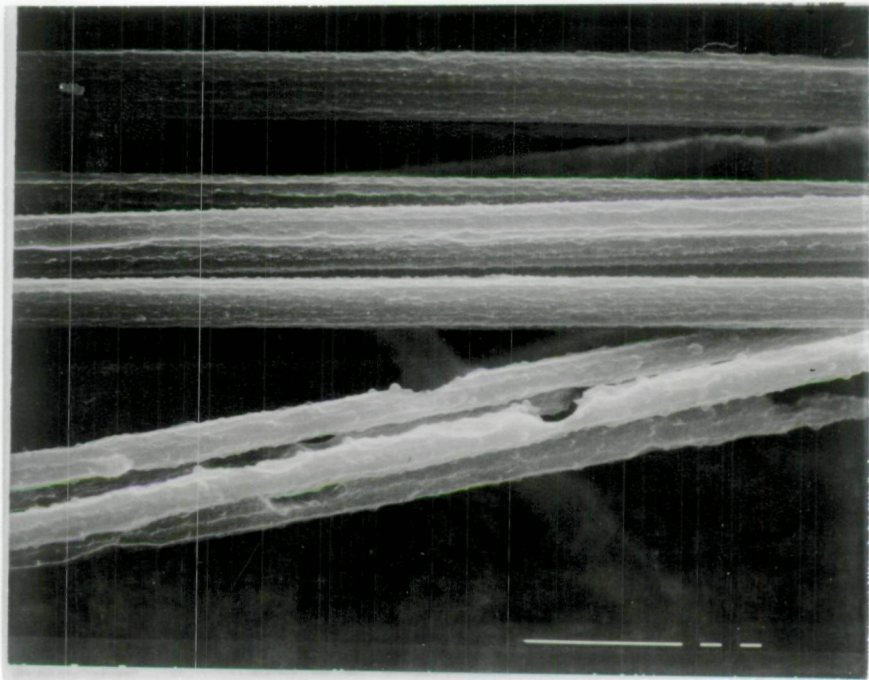
Fig. 4-24

Fig. 4-24(b) Silicon Carbide Coating from
UCC L-31 Silicone Fluid
1350X

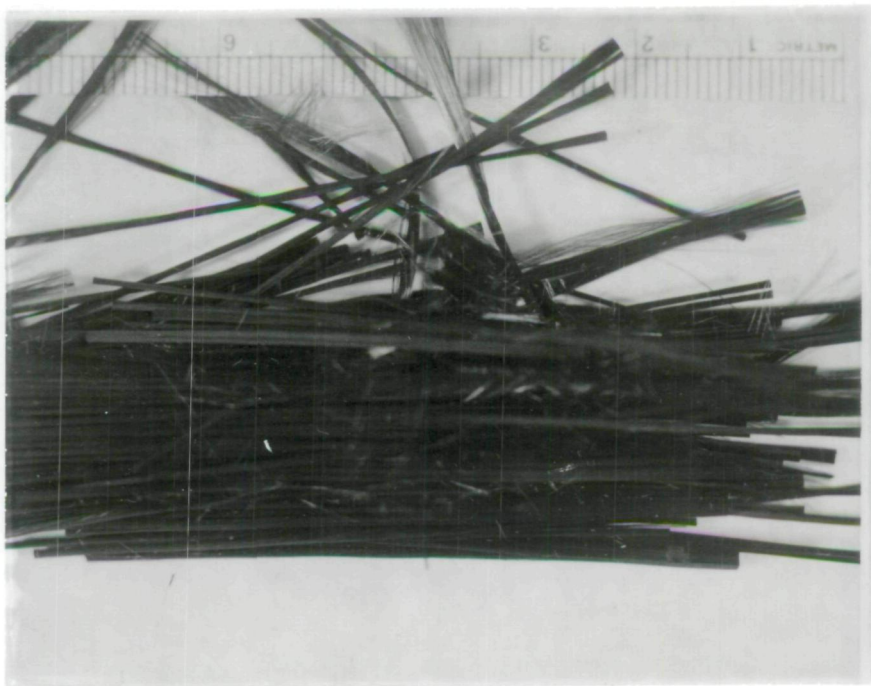
Fig. 4-25(a) Composite After 10 Minutes
Dynamic Burn Test, 850°C Max.,
1.5 x 10⁶ dyne·cm Impact Energy,
11 M/sec. Air Velocity. Scale is
Centimeters.

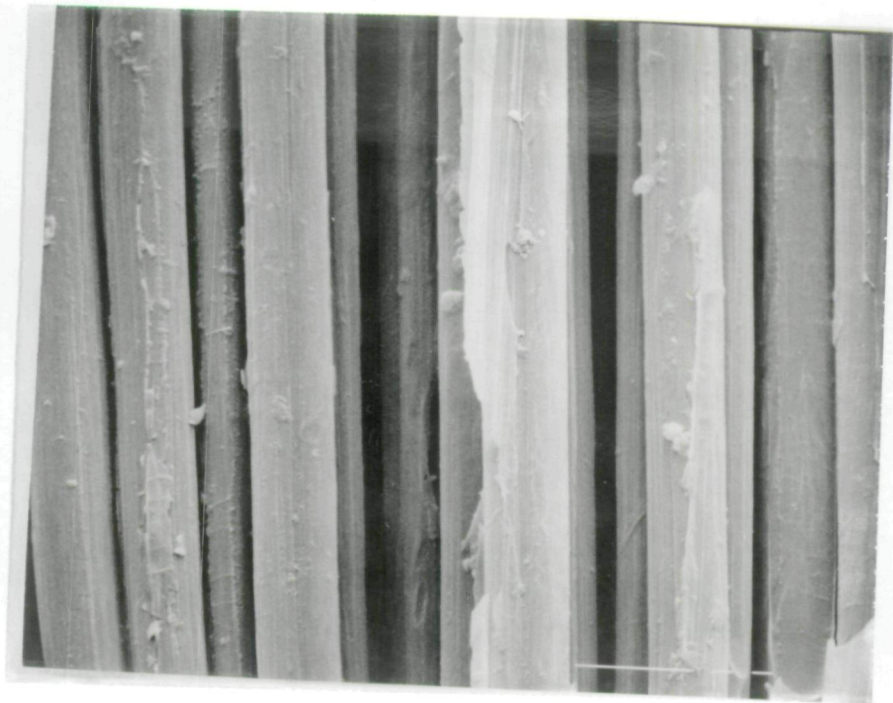
Fig. 4-24(b) SEM Micrograph from One of the
Larger Pieces Remaining After Burn
Testing. 1350X

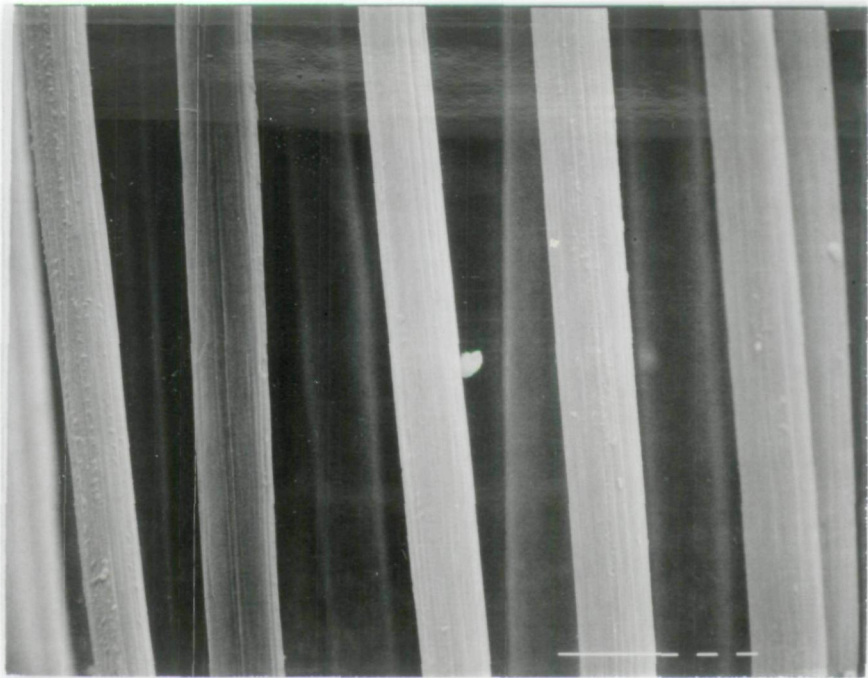
Fig. 4-25(c) SEM Micrograph from Fuzzy Edge
of a Smaller Piece Remaining After
Burn Testing.

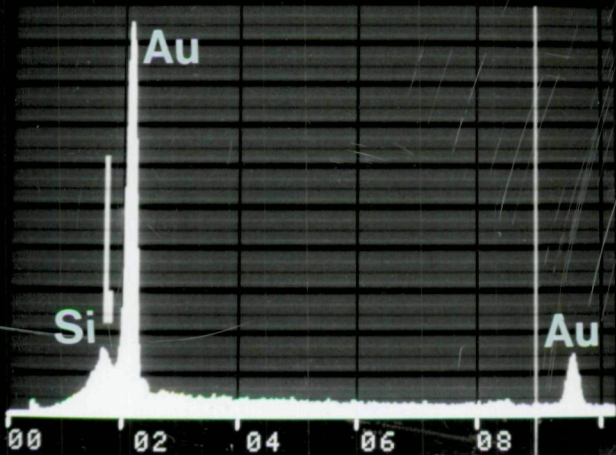
Fig. 4-25(d) Kevex Trace of Burned Composite Showing Gold Coating and Silicon Levels Similar to Control Samples.

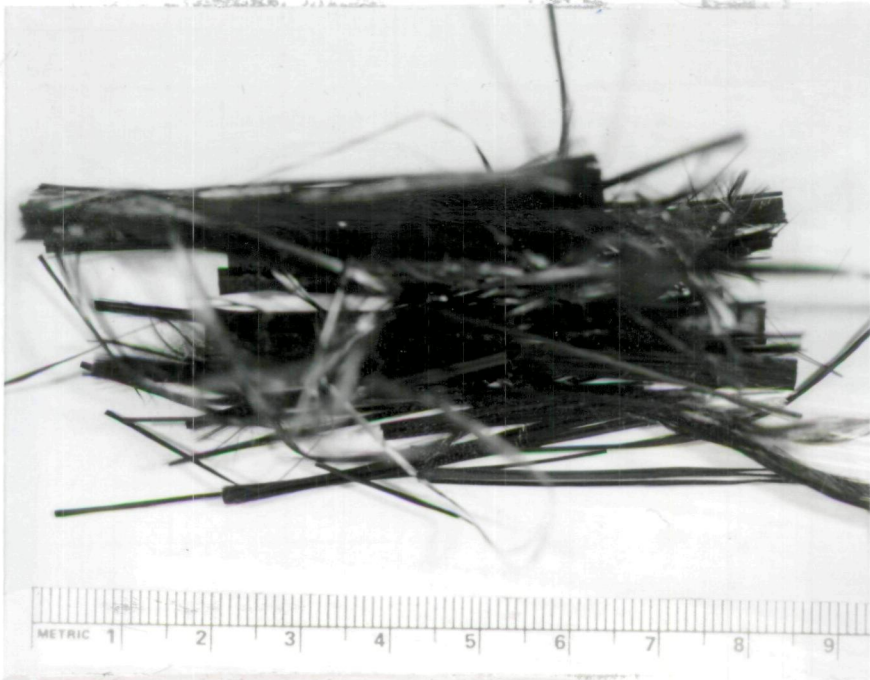
Fig. 4-26(a) Composite After 10 Minutes
Dynamic Burn Test, 850°C Max.,
 1.5×10^6 dyne·cm Impact Energy,
11 M/sec. Air Velocity. Approximately
50% of Fibers Burned Away. Scale is
Centimeters.

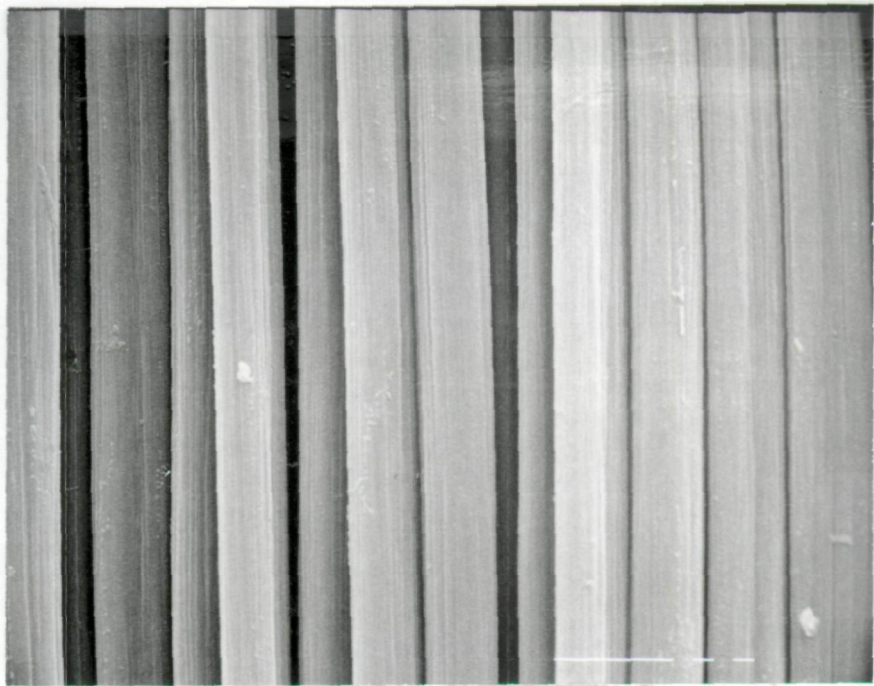
Fig. 4-26(b) SEM Micrograph from One of the
Larger Pieces Remaining After Burn
Testing.

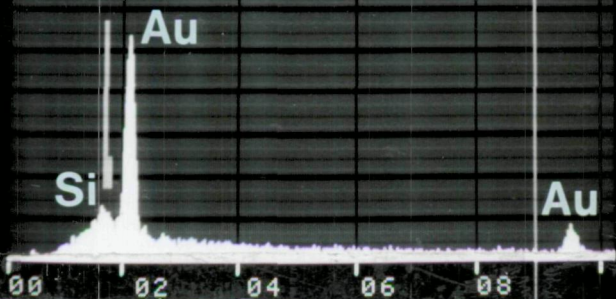
Fig. 4-26(d) Kevex Trace of Burned Composite
Showing Gold Coating and Silicon
Levels Similar to Control Samples.

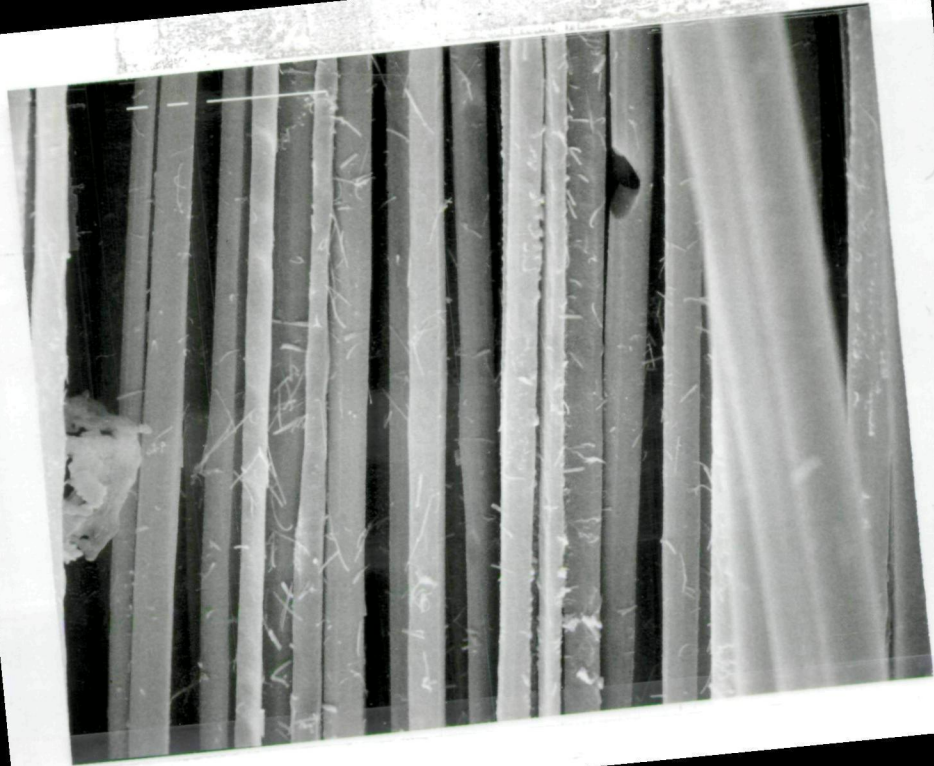
Fig. 4-26(c) SEM Micrograph from Edge of a
Sample Piece Remaining After Burn
Testing. 1350X

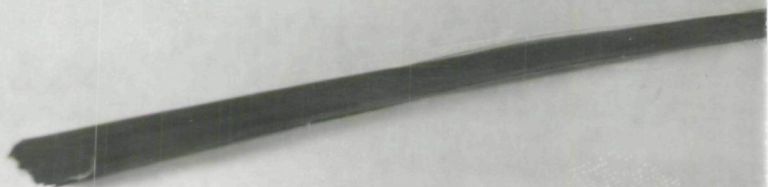
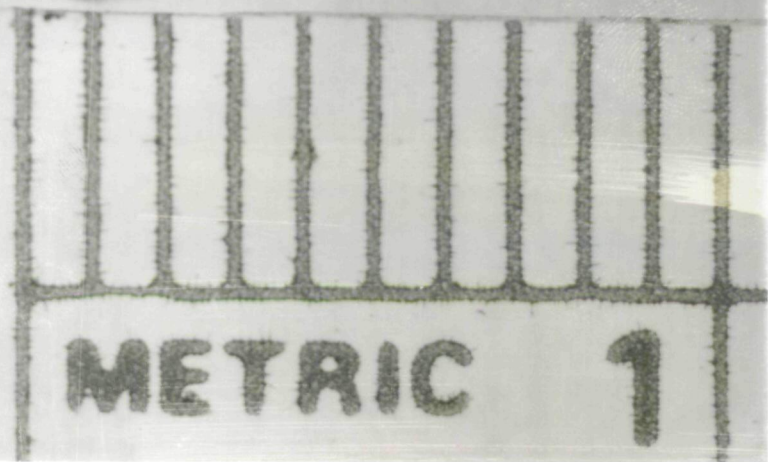
Fig. 4-27. "Thornel" 300 Carbon Fiber
with UC-309 Size Showing
Bundle Integrity. Scale is
Centimeters.
